MSHA Report of Investigation  
 Loveridge No. 22 Mine Fire / Explosion

MSHA Report of Investigation  
Loveridge No. 22 Mine Fire / Explosion  
June 22, 1999

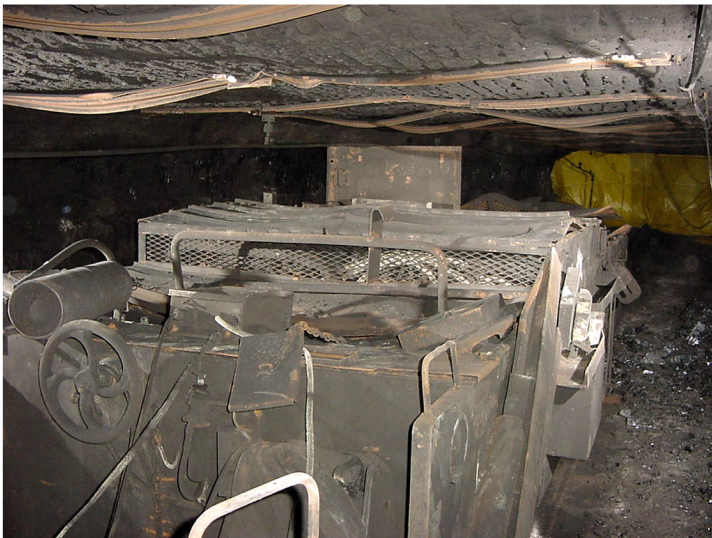
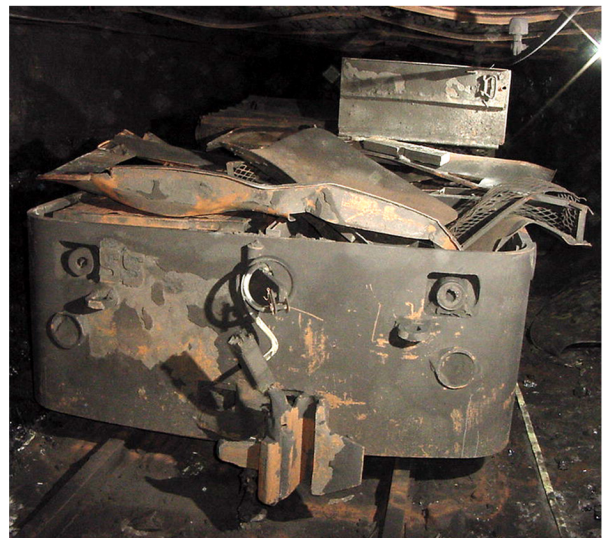
**Figure 29 (center left):** Outby end of Locomotive #55.

**Figure 30 (center right):** Inby end of Locomotive #55.

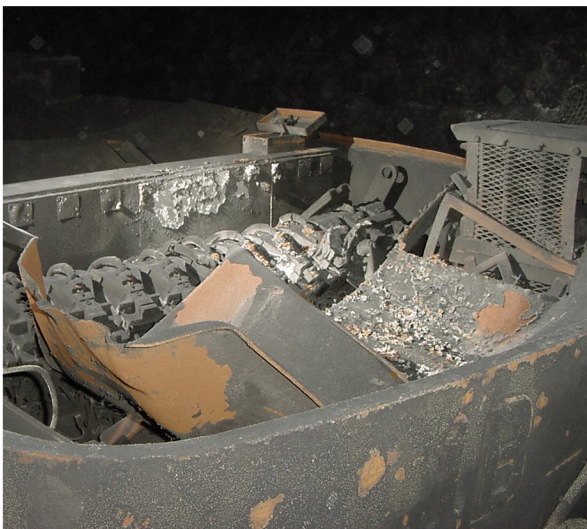
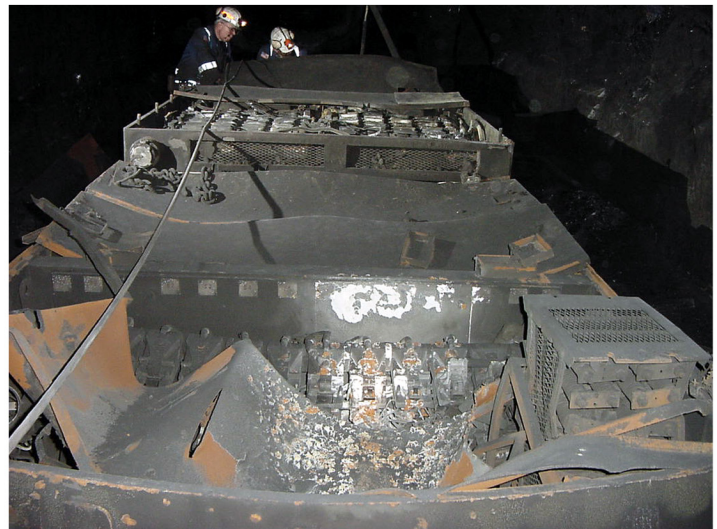
**Figure 33 (center left):** Inby end of Locomotive #1B.

**Figure 34 (center right):** View across the top of Locomotive #1B.

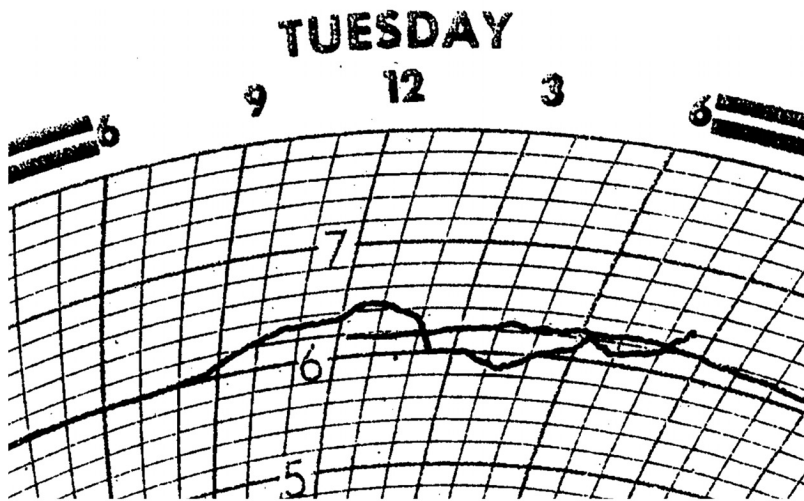
Figure 49 - Miracle Run Fan  
Pressure Recording Chart  
MSHA Report of Investigation  
Loveridge No. 22 Mine Fire / Explosion  
June 22, 1999

Note: Fan chart recording period:  
12:03 p.m., June 15, 1999  
to  
8:40 p.m., June 22, 1999
